ARTHUR OKWEMBA

KCC DANDORA

NEW KCC DANDORA RECP AND IS DEVELOPED CASE

Main Function : Dairy processing factory

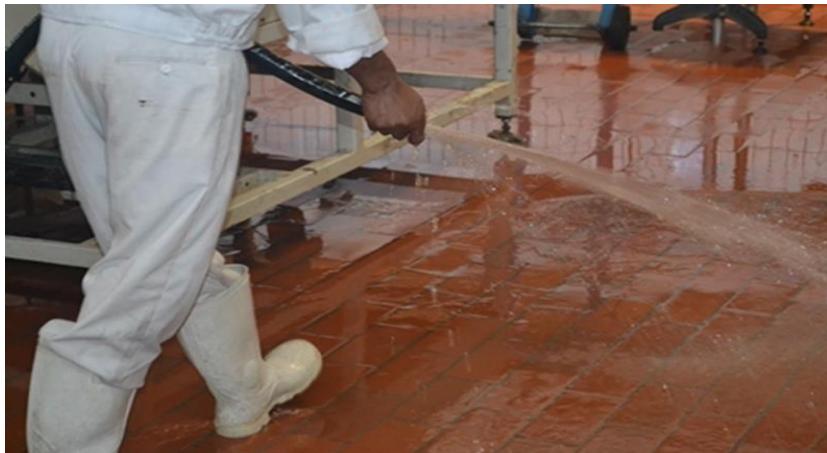
- ❖ Notable water leakages
- ❖ No sub metering of the main water usage points.
- ❖ cleaning with pipes that have no water guns.
- ❖ water from the borehole not metered and general waste water management challenges

Photo showing water wastage during cleaning of the production floor

- ❖ Installed a new CIP system installed which saves up to 30% of recovered water,
- ❖ water audit done,
- ❖ awareness creation,
- ❖ purchase of valves,
- ❖ water hoses and fitting
- ❖ installed road tanker re-use pump and water tank , the water is now used to wash crates

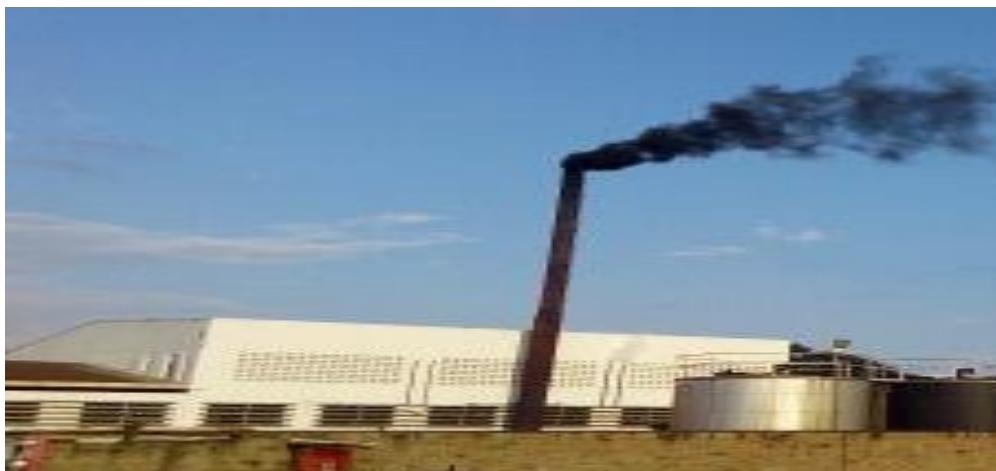
- ❖ There was no individual metering of energy usage in the factory
- ❖ High energy consumption light fittings i.e T12 tubes and incandescent light bulbs.
- ❖ High load motors used.
- ❖ Poor lagging and steam leakages, smoke causing pollution

Photo showing and old smoking burner

- ❖ Serviced ammonia compressor and evaporative condenser
- ❖ serviced ammonia system replaced valves
- ❖ serviced boiler and installed new burner,
- ❖ steam fittings and valves and make up pumps,
- ❖ installed LED lights , PF c/banks, VSDs,

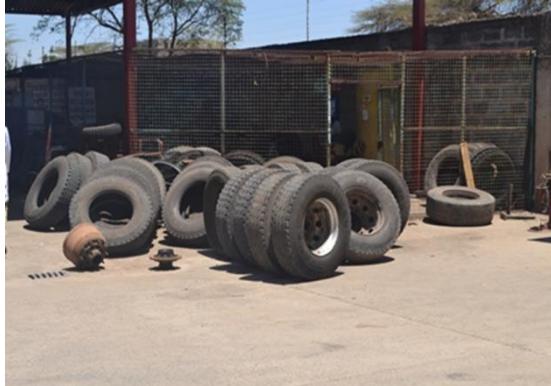
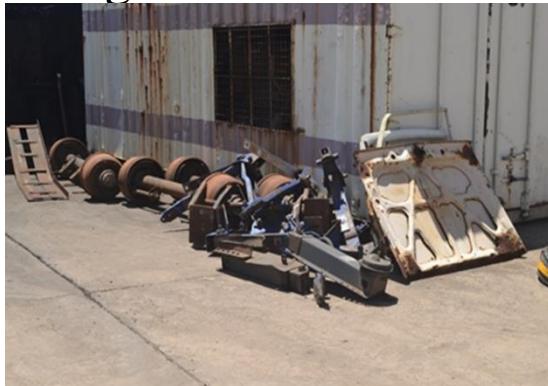
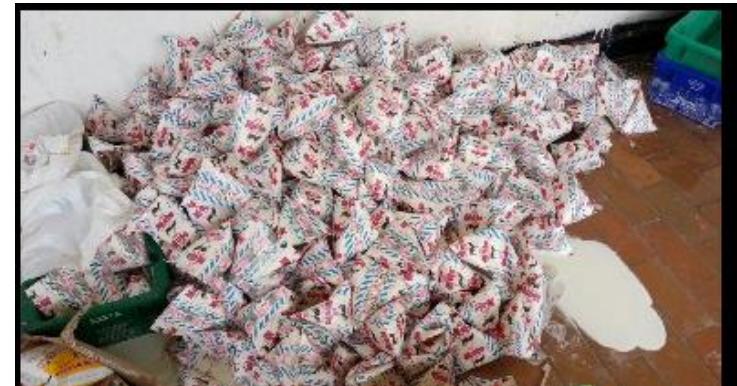
- ❖ The main solid wastes produced were broken milk crates.
- ❖ Wood waste
- ❖ Plastic waste
- ❖ Scrap metal
- ❖ Cartons and electrical waste from electrical machines.
- ❖ No designated solid waste disposal/holding site.
- ❖ Heavy furnace oil (HFO) leakages

Photo showing some of the waste generated at the New KCC

New mala pump installed to reduce product leaks and milk returns sold as piggery to farmers

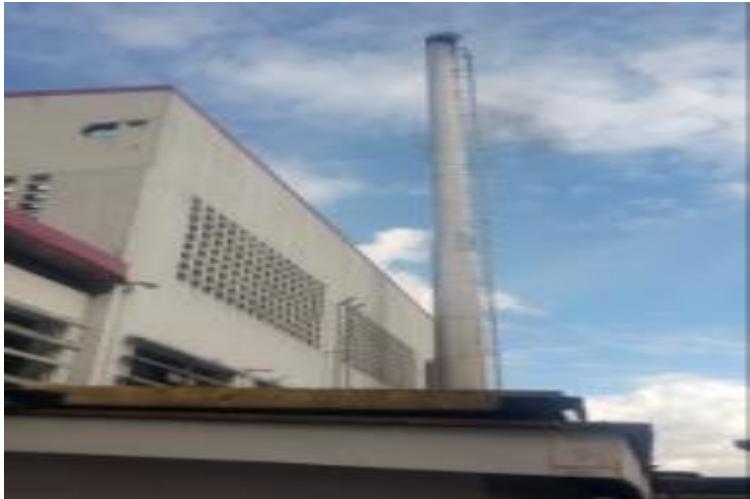
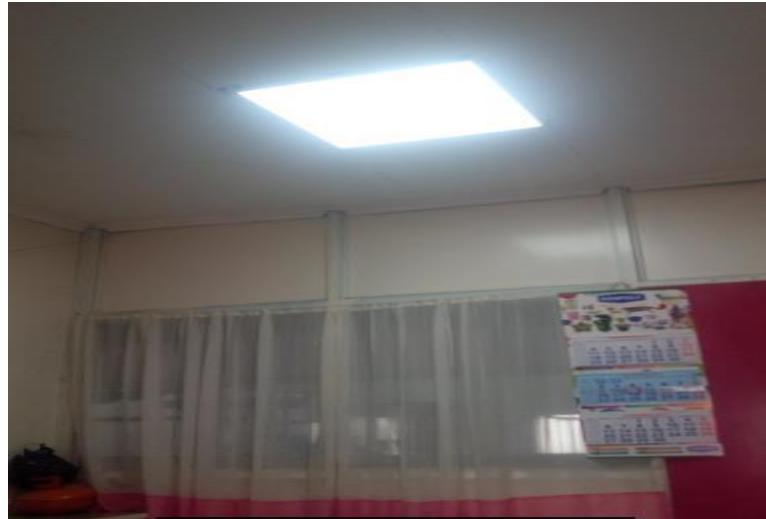
Photo showing the newly installed burner with no smoke Photo showing LED light installed at the factory

1. Good co-existence between the company and the community
2. 30% savings on recovered water
3. Environmental pollution reduction through installation of a new burner
4. With a saving of 160 litres of HFO per day, Ksh 11,520 per day or 4.1 M per year
5. Energy savings of KES 1.2m per month about Ksh14.4M per year
6. Water savings from 700 m³ to 590 m³ per day about ksh 17,380 per day or Ksh 6.3M per year
